Concrete Masonry
Checkoff

THERMAL BRIDGES IN WALL CONSTRUCTION

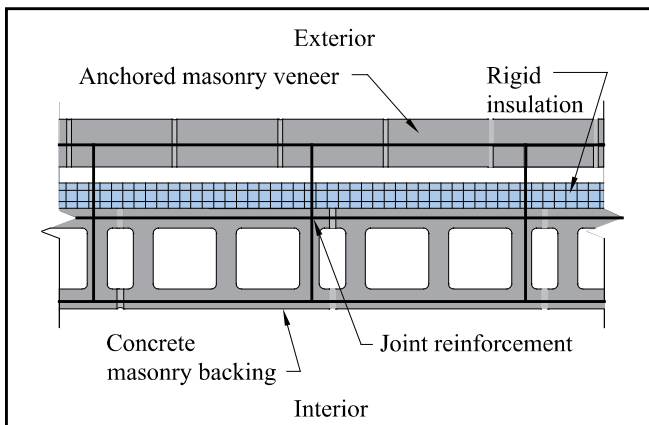
In masonry cavity walls, insulation is typically placed between the two wythes of masonry, as shown in Figure 1. This provides a continuous layer of insulation, which minimizes the effects of thermal bridging (note that some references term the space between furring or studs as a “cavity,” which differs from a masonry cavity wall).

Figure 1—Insulated Masonry Cavity Wall

Because the wall ties are isolated from the interior, the interior surface of the wall remains at a temperature close to the building’s interior temperature. The interior finish material is not likely to be damaged due to moisture condensation, and occupant comfort is not likely to be affected. As with horizontal joint reinforcement in single wythe construction, the type, size, and spacing of the ties will affect the potential impact on energy use.

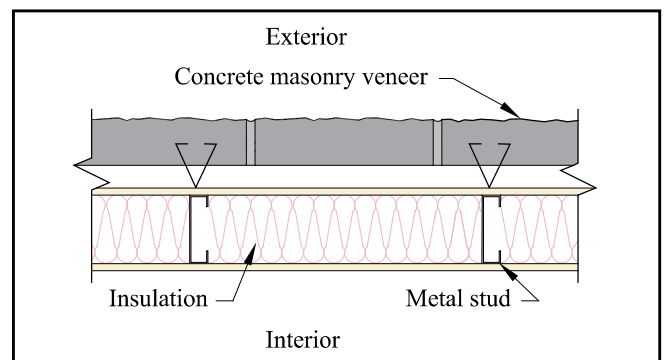
Figure 2 shows a cross section of a typical concrete masonry veneer over a steel stud backup. Steel studs act as strong thermal bridges in an insulated wall system. Almost 1,000 times more heat flows through the steel than through mineral fiber insulation of the same thickness and area. The steel stud allows heat to bypass the insulation, and greatly reduces the insulation’s effectiveness.

Figure 2—Concrete Masonry Veneer with Steel Stud Backup

Just as for concrete masonry webs, the thermal bridging through steel studs must be accounted for. According to ASHRAE Standard 90.1, acceptable methods to determine the R-value of insulated steel studs are: testing, modified zone calculation method, or using the insulation/framing layer adjustment factors shown in Table 1. The effective framing/cavity R-value shown in Table 1 is the R-value of the insulated steel stud section, accounting for thermal bridging. Using these corrected R-values allows the designer to adequately account for the increased energy use due to the thermal bridging in these wall assemblies.

Table 1 shows that thermal bridging through steel studs effectively reduces the effective R-value of the insulation by 40 to 69 percent, depending on the size and spacing of the steel studs and on the R-value of the insulation.

Because the steel studs are typically in contact with the interior finish, local cold spots can develop at the stud locations. In some cases, moisture condenses causing dampness along these strips. The damp areas tend to retain dirt and dust, causing darker vertical lines on the interior at the steel stud locations. If warm, moist indoor air penetrates into the wall, moisture is likely to condense on the outer flanges of the steel studs, increasing the potential for corrosion of studs and connectors and structural damage of the wall. Gypsum sheathing on the exterior of the studs can also be damaged due to moisture, particularly during freeze-thaw cycles. These impacts can be minimized by including a continuous layer of insulation over the steel stud/insulation layer.

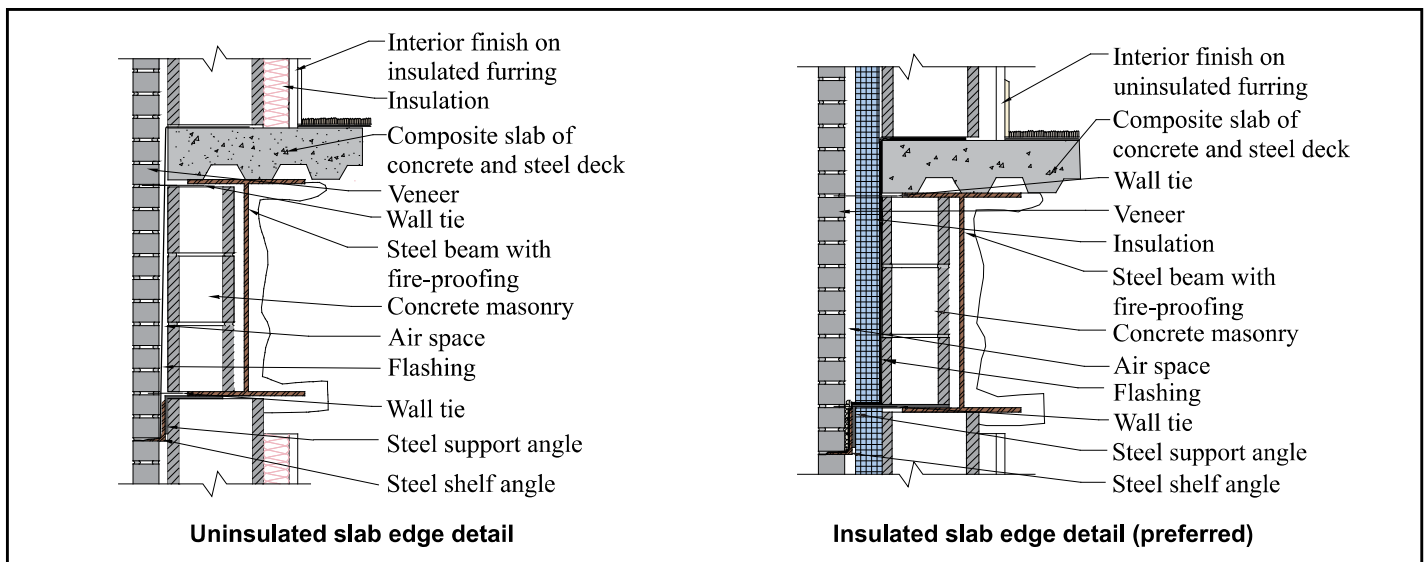
Another common thermal bridge is shown in Figure 3. When this wall system is insulated on the interior, as shown on the left, thermal bridging occurs at the steel beam and where the concrete floor slab penetrates the interior masonry wythe.

A better alternative is to place insulation in the cavity, as shown on the right in Figure 3, rather than on the interior. This strategy effectively isolates both the slab edge and the steel beam from the exterior, substantially reducing heat flow through these areas and condensation potential, and decreasing heating loads (ref. 3).

Figure 3—Alternative Insulation Strategies for Slab Edge and Perimeter Beam

A third alternative, not illustrated, is to install insulation on the interior of the steel beam. This solution, however, does not address the thermal loss through the slab edge. In addition, the interior insulation causes the temperature of the steel beam to be lower, and can lead to condensation unless a tight and continuous vapor retarder is provided.

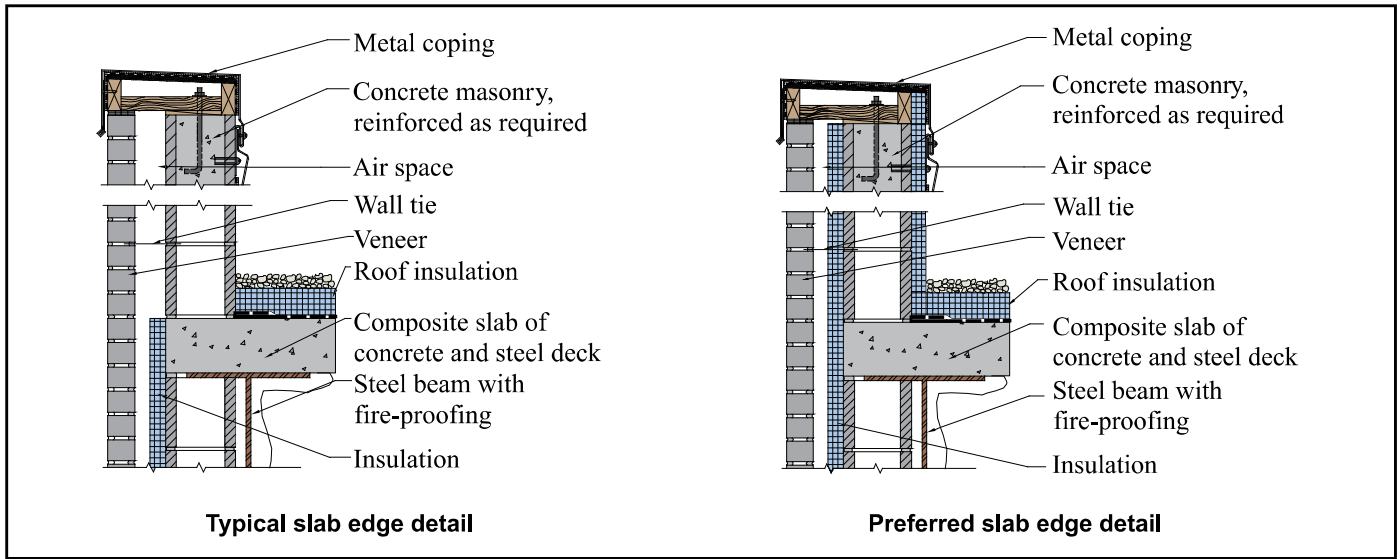
Because a parapet is exposed to the outside environment on both sides, it can act as a thermal fin, wicking heat up through the wall. Figure 4 shows two alternative insulation strategies for a masonry parapet. On the left, even though the slab edge is insulated, the parapet is not. This allows heat loss between the roof slab and the masonry backup.

A better alternative is shown on the right in Figure 4. Here, the parapet itself is insulated, maintaining a thermal boundary between the interior of the building and the outdoor environment. This significantly reduces heating and cooling loads, and virtually eliminates the potential for condensation on the underside of the roof slab.

Figure 4—Alternative Insulation Strategies for a Masonry Parapet
